DEPARTMENT OF TRANSPORTATION

Contract #: 04-0120F4Cty: SF/ALA Rte: 80 PM: 13.2/13.9File #: 69.28**WELDING INSPECTION REPORT****Resident Engineer:**Siegenthaler, Peter**Address:** 333 Burma Road**City:** Oakland, CA 94607**Report No:** WIR-018521**Date Inspected:** 28-Nov-2010**Project Name:** SAS Superstructure**OSM Arrival Time:** 700**Prime Contractor:** American Bridge/Fluor Enterprises, a JV**OSM Departure Time:** 1900**Contractor:** Zhenhua Port Machinery Company, Ltd (ZPMC), Changxing Island **Location:** Shanghai, China**CWI Name:** Li Yang**CWI Present:** Yes No**Inspected CWI report:** Yes No N/A**Rod Oven in Use:** Yes No N/A**Electrode to specification:** Yes No N/A**Weld Procedures Followed:** Yes No N/A**Qualified Welders:** Yes No N/A**Verified Joint Fit-up:** Yes No N/A**Approved Drawings:** Yes No N/A**Approved WPS:** Yes No N/A**Delayed / Cancelled:** Yes No N/A**Bridge No:** 34-0006**Component:** OBG Segment**Summary of Items Observed:**

OBG # TRIAL ASSEMBLY YARD (Lift 11W)

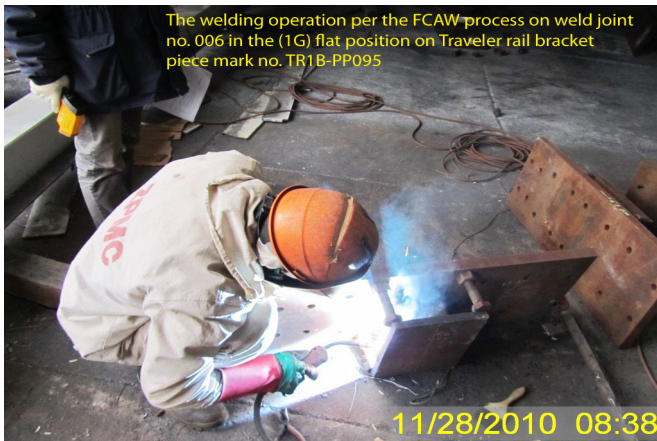
For additional information please reference the pictures below:
